**Flood Control Project Maintenance
Levee Inspections**

Maintenance Issue Types Only, Levee Inspection Report By Mile - Fall 2015

Reclamation District No. 0551 Pearson

Waterway	Bank	Unit Miles	Inspection Start/End	Inspector
Unit No. 01 Sacramento River	Left	6.78	10/14/2015 10/14/2015	Herman Phillips

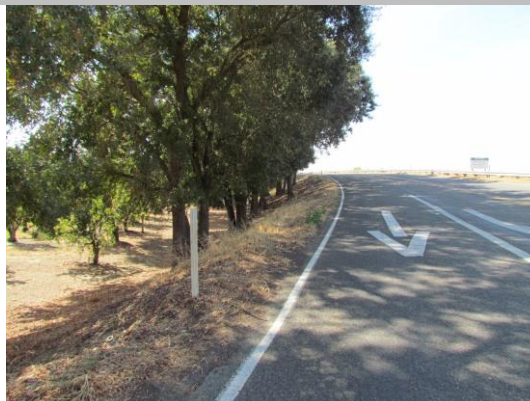
Photo 1 of 1 : FA_2015_RD0551_175_27_20151019_00018.jpg

LM Start	0.00	Rating **	A	Issue No.	27
LM End	6.78	Issue Type +	Ma	Location *	LS
Category	Earthen Levee			GPS Latitude/Longitude	
				Start	End
Item	Vegetation			38.336439 °	38.258886 °
				-121.564765 °	-121.517901 °
DWR ID	DWR_RD0551_01_f_2015_27				
Action/Comments					
Control annual grass and weeds on the levee slopes and easements. Inspector Comments: All unwanted has been removed from the levee section.

Looking downstream from levee mile 0.00 to levee mile 6.78 all unwanted grasses has been removed from both the landside and waterside levee slopes.

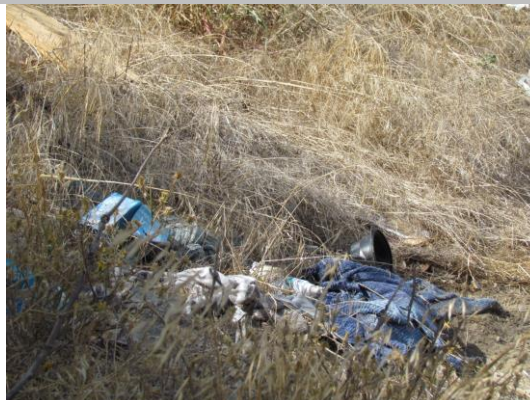
Photo 1 of 2 : FA_2015_RD0551_175_25_20151019_00016.jpg

RD 551 looking downstream from levee mile 0.02 garbage dumped on the waterside slope.

LM Start	0.03	Rating **	M	Issue No.	25
LM End	0.03	Issue Type +	Ma	Location *	WS
Category	Earthen Levee			GPS Latitude/Longitude	
				Start	End
Item	Encroachments			38.336123 °	38.336123 °
				-121.565022 °	-121.565022 °
DWR ID	DWR_RD0551_01_f_2015_25				
Action/Comments					
Garbage Inspector Comments: Remove the garbage and mattress from the waterside slope.

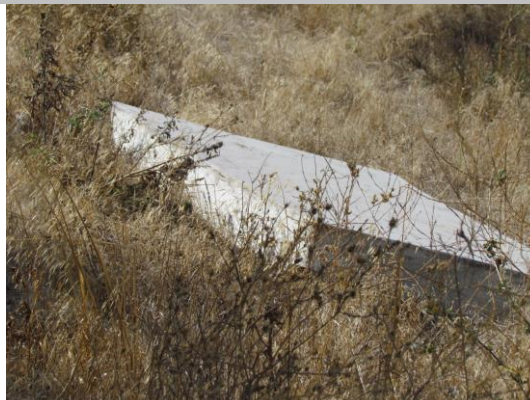
Photo 2 of 2 : FA_2015_RD0551_175_25_20151019_00017.jpg

Discarded mattress dumped on the waterside slope.
